Division of Health Service Regulation

STATEMENT OF DEFICIENCIES AND PLAN OF CORRECTION	(X1) PROVIDER/SUPPLIER/CLIA IDENTIFICATION NUMBER: HAL049031	(X2) MULTIPLE CONSTRUCTION A. BUILDING: 01 B. WING: _____	(X3) DATE SURVEY COMPLETED 05/21/2015
--	---	---	--

NAME OF PROVIDER OR SUPPLIER CARILLON ASSISTED LIVING OF MOORESVIL	STREET ADDRESS, CITY, STATE, ZIP CODE 198 E WATERLYNN RD MOORESVILLE, NC 28117
---	--

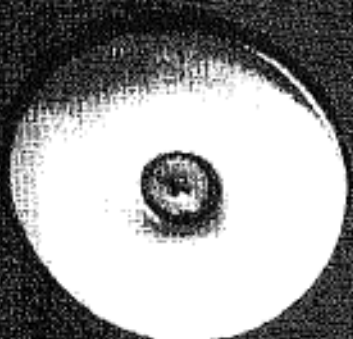
#

Hole in
the
